Selina Laur

Andreas Jenni, Marco Herwegh, Alfons Berger, Roger Zurbriggen

Institute of Geological Sciences, University of Bern and LPM AG, Beinwil am See

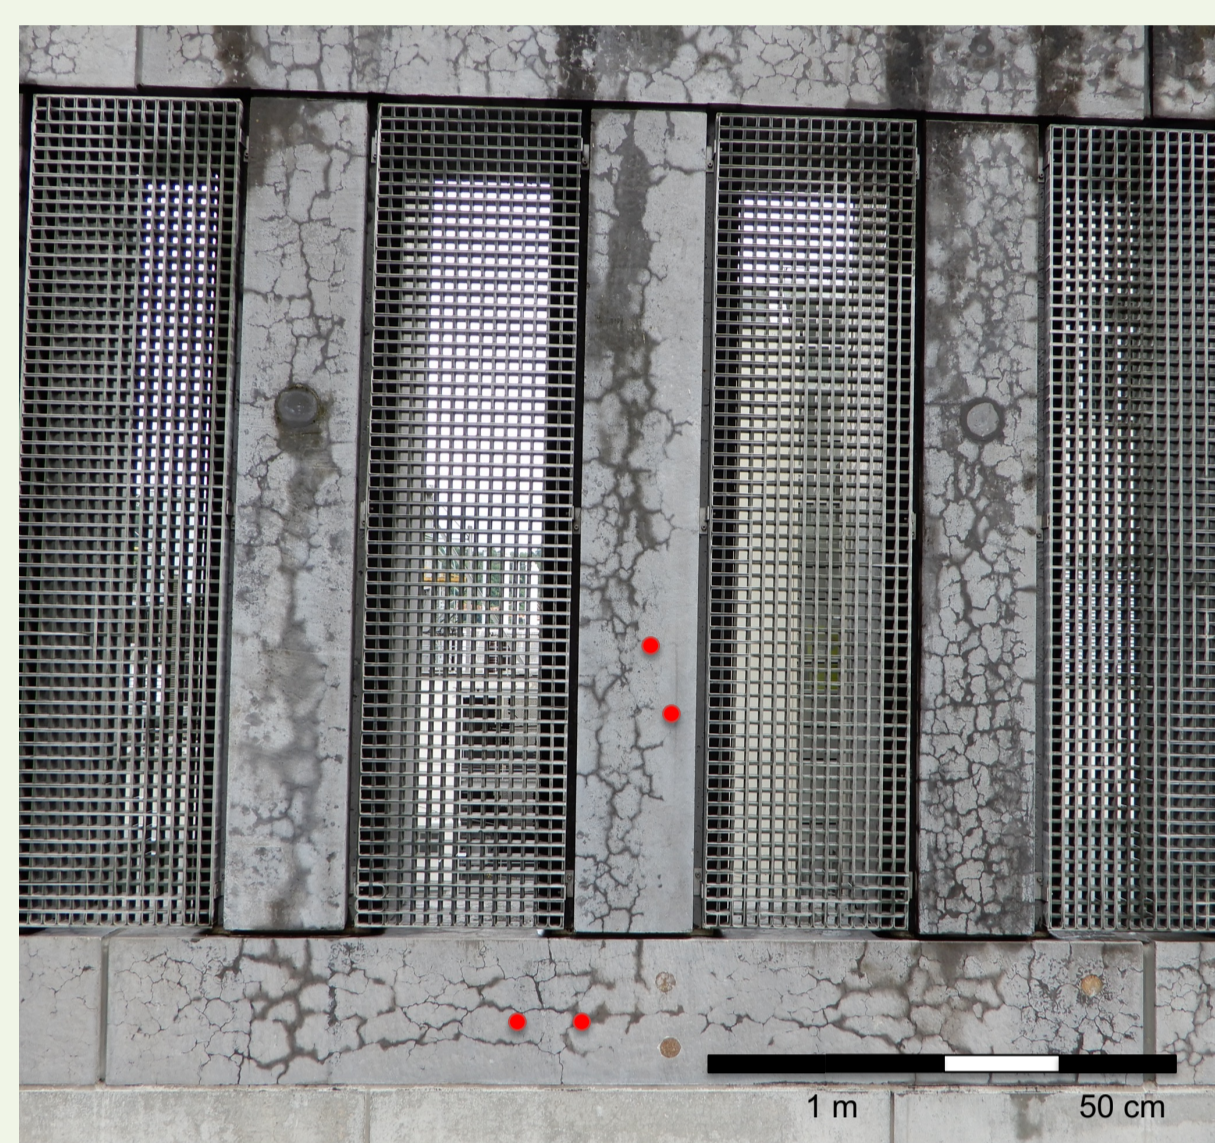
Figure 1: Concrete precast elements of a damaged building wall with the collected drill core samples in red.

The surface crack mapping and the measurements of the crack width index (RI) allowed an initial assessment of the damage caused by ASR (see Figures 1 and 2). The RI is a widely used method for estimating ASR-induced damage [2].

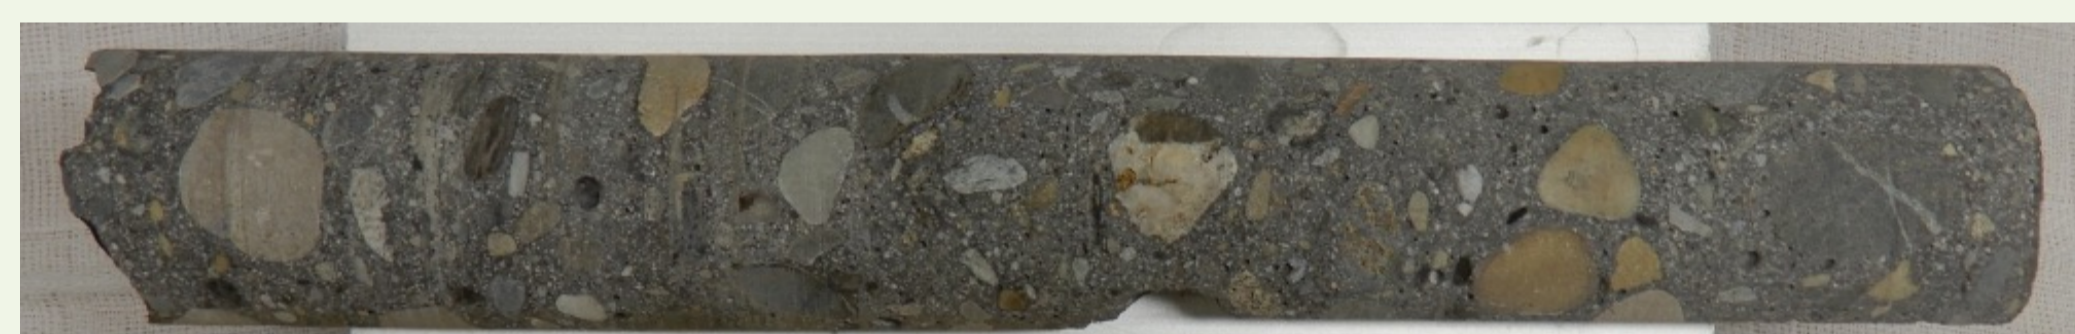
Figure 3: Drill core with a diameter of 3 cm and a length of 21 cm.

The drill cores (see Figure 3) were processed to thin sections using UV resin, to better visualise the cracks, pores and ASR products within.

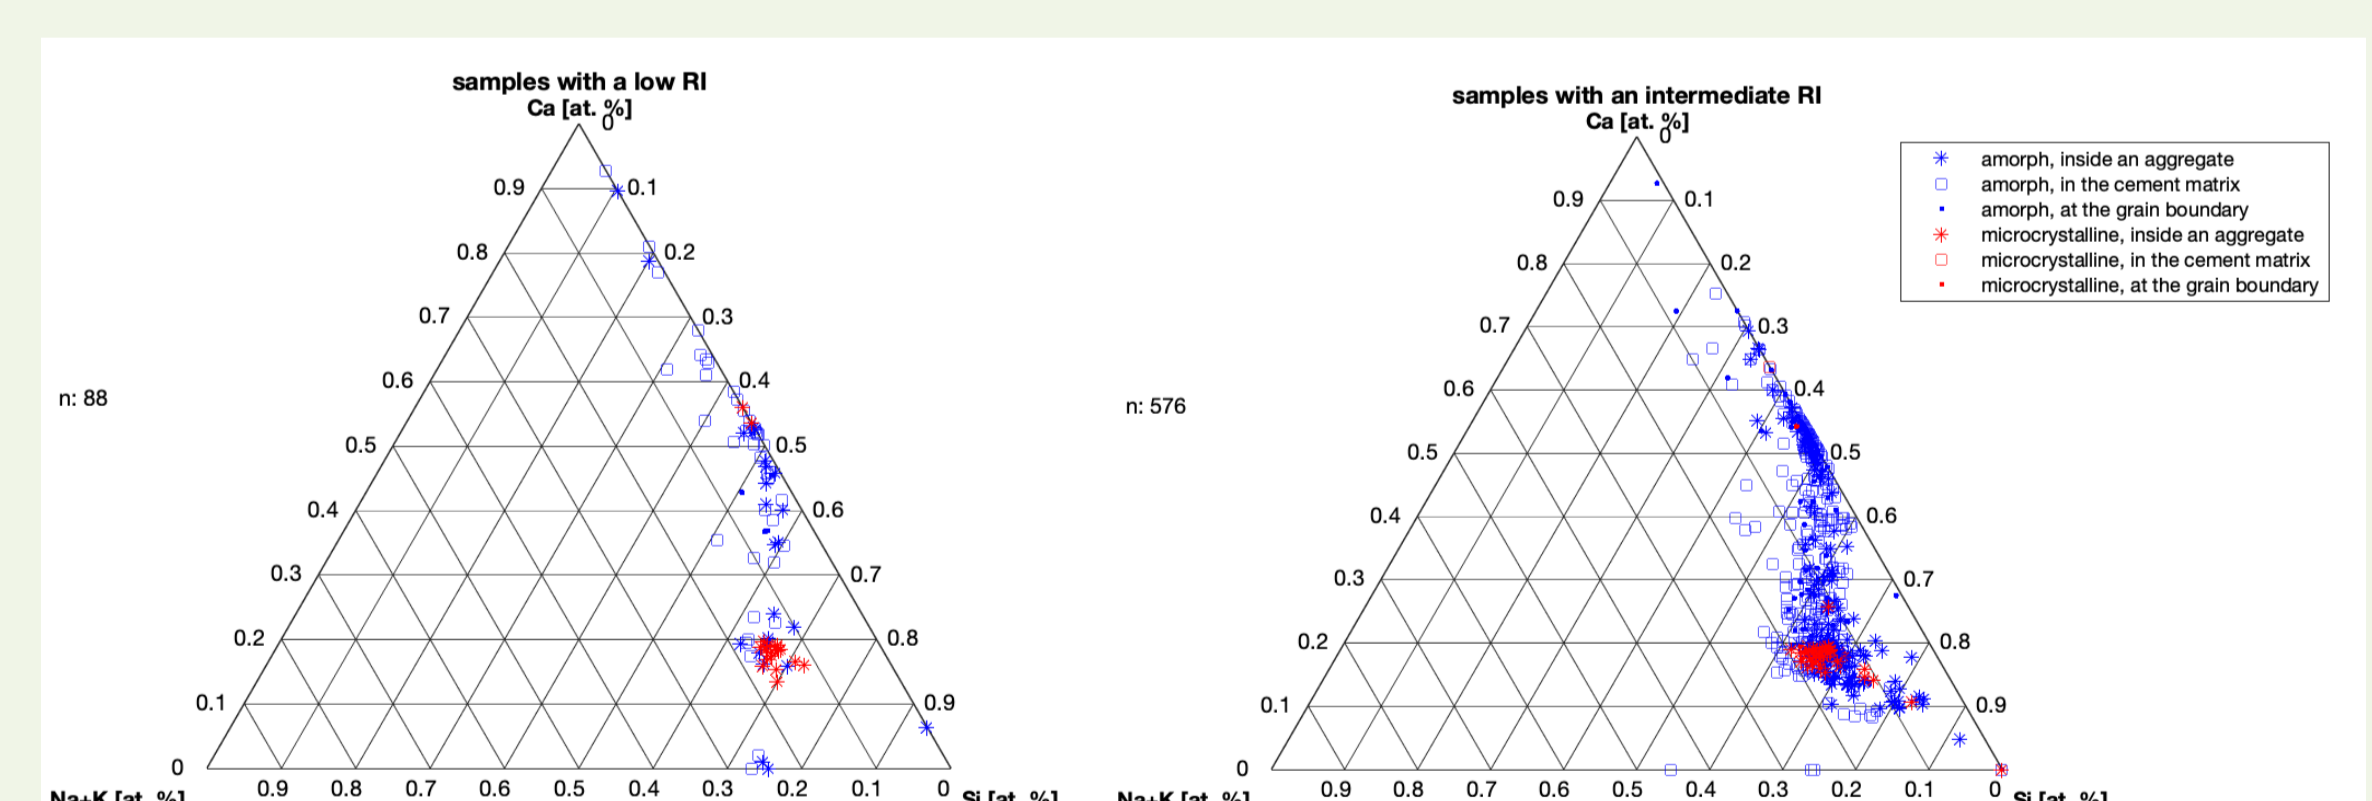
Figure 6: EDAX measurements in ternary diagrams (Ca, Si and Na+K in atomic fractions), from samples representing intermediate RI values (1-3 mm/m; samples 1 and 2) and low RI values (<1 mm/m; samples 3 and 4).

- The chemistry of microcrystalline ASR products show little variation, while the amorphous products have a wide range of chemical compositions. As the concentration of Ca increases, the levels of Na and K decrease.
- There is no chemical difference between ASR products from more damaged (high RI) and less damaged (low RI) areas.
- The majority of microcrystalline ASR products are located within aggregates (see Figure 6).
